**PHASE 1 REPORT AND WORK PLAN**  
**CHARACTERIZATION OF CAULK IN CONCRETE PAVEMENTS**  
**AT BOEING PLANT 2**

**Boeing Plant 2**  
**Seattle/Tukwila, Washington**

**May 2008**

**Golder Associates Inc.**  
**18300 NE Union Hill Rd, Suite 200**  
**Redmond, Washington 98052**

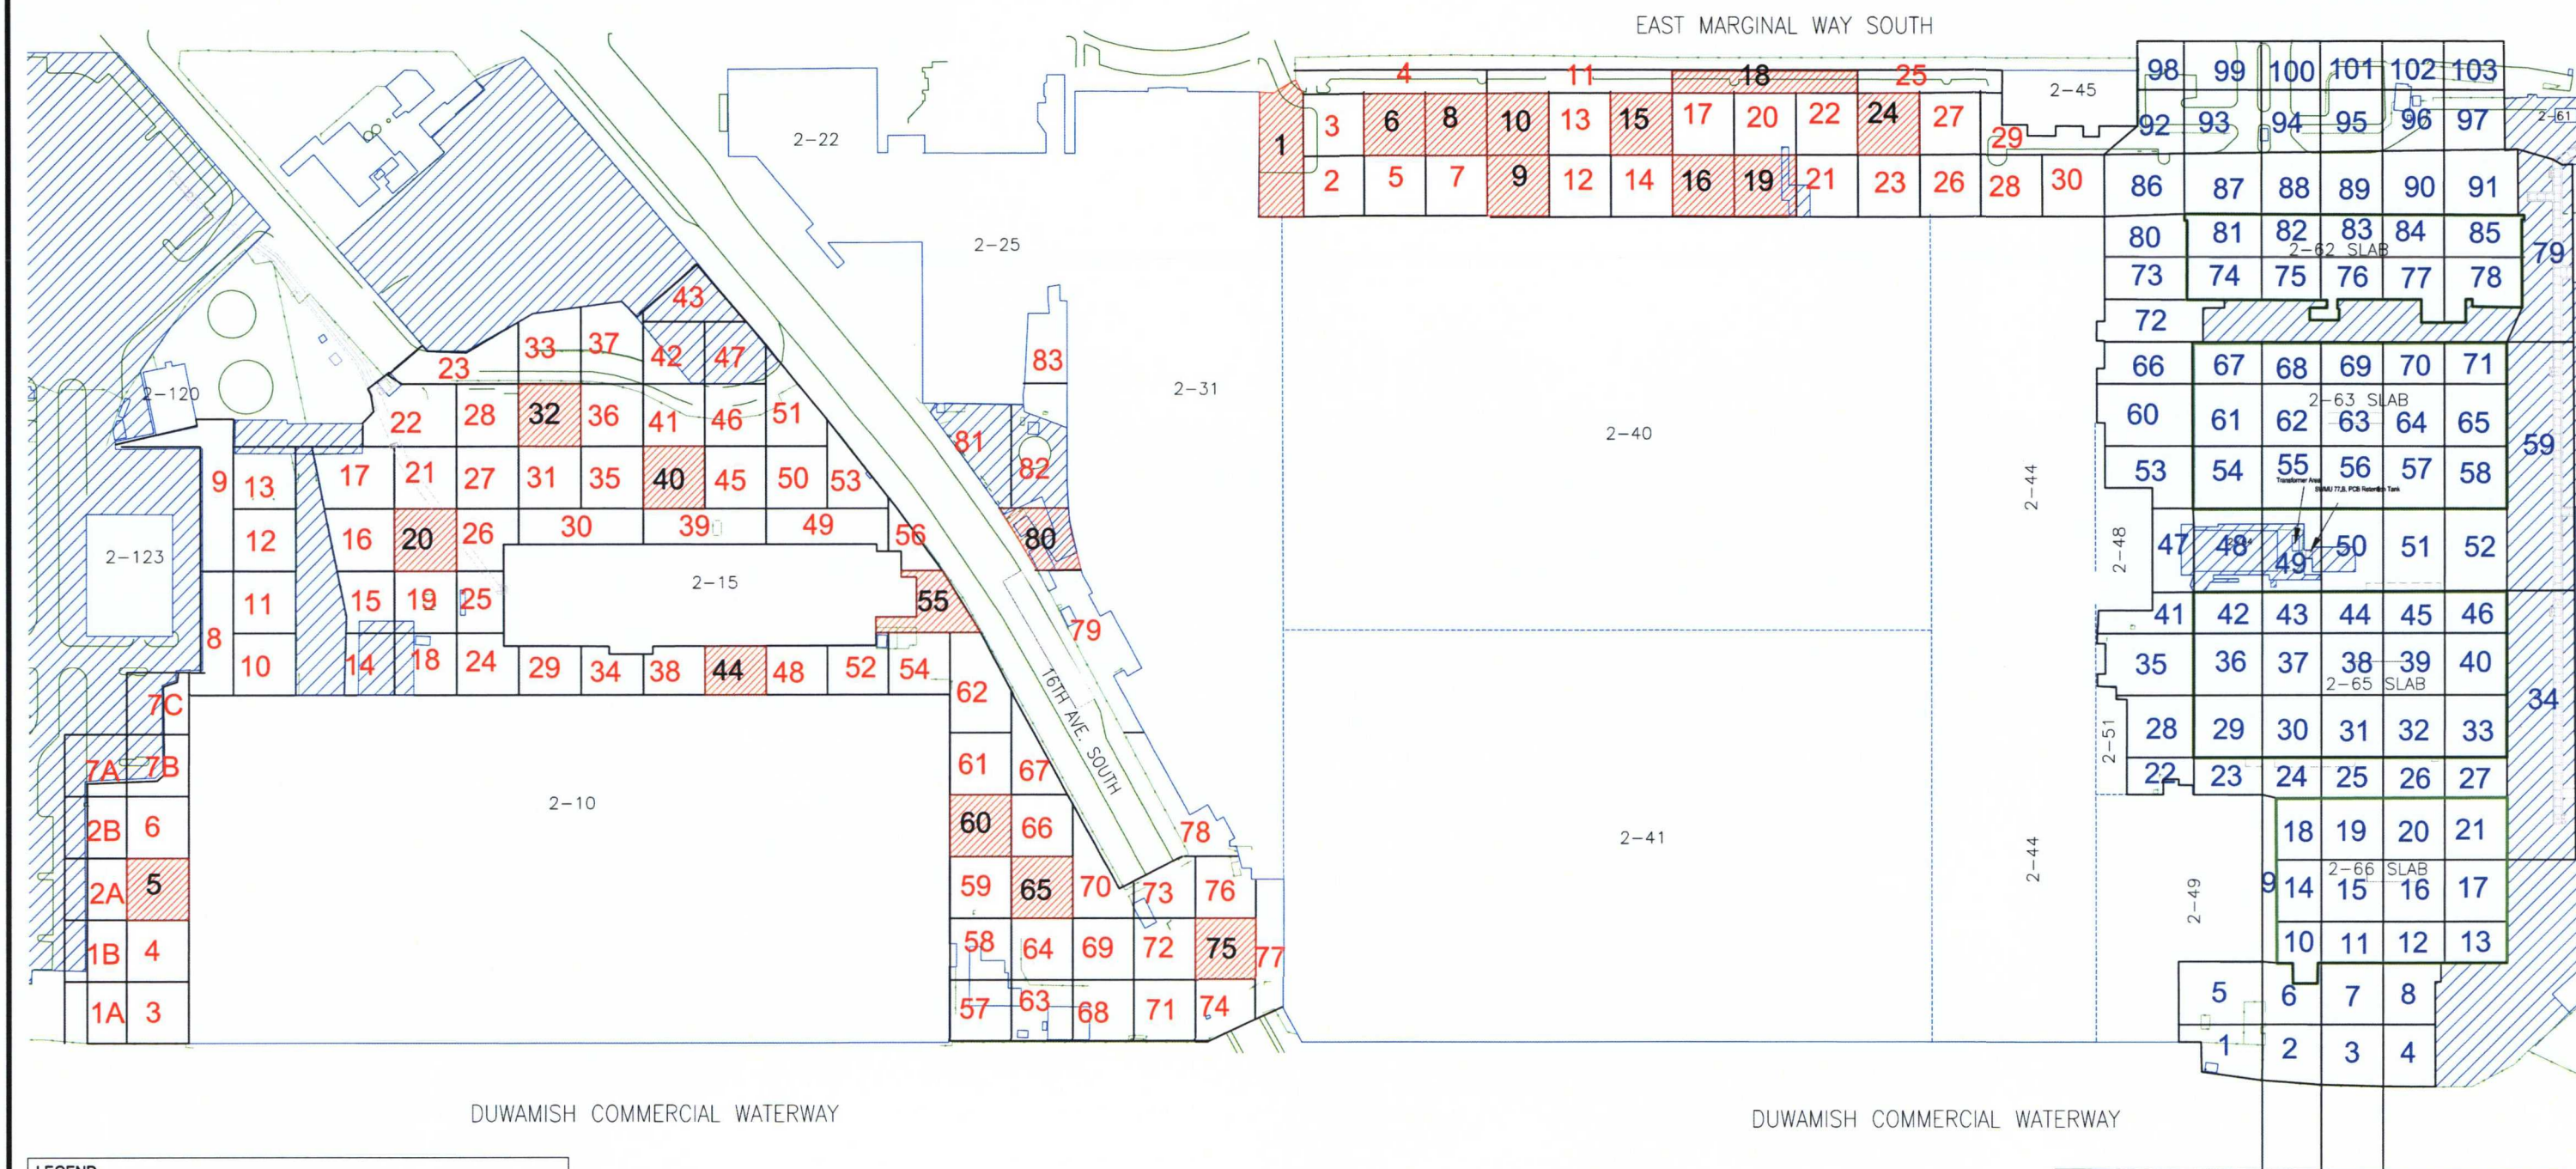
FIGURE 4  
2-10 AREA CAULK SAMPLE LOCATIONS AND RESULTS  
PHASE 1 CAULK CHARACTERIZATION  
Golder Associates

As a result of this investigation, a total of 33 samples were collected and eight caulk types were identified in the 2-10 Area. The caulk types and PCB concentrations of those materials are discussed below, presented in attached Tables 1 & 2, and shown on Figure 4. Tables 1 and 2 also include comments regarding the general condition of the caulks at the locations sampled.
